# COMPLEX CASE SERIES OF PATIENTS WITH VARIOUS STAGNATING WOUNDS TREATED WITH A COLLAGEN DRESSING IN A NURSING HOME SETTING

Ria van Dam, RN wound care specialist nurse, Tineke Krikke, MD, nursing home physician specialist

St. Jacob Foundation, Louis Pasteurstraat 9, 2035 RJ Haarlem, Netherlands. Tel: +31238923900.  
r.van.dam@sintjacob.nl; t.krikke@sintjacob.nl; www.sintjacob.nl

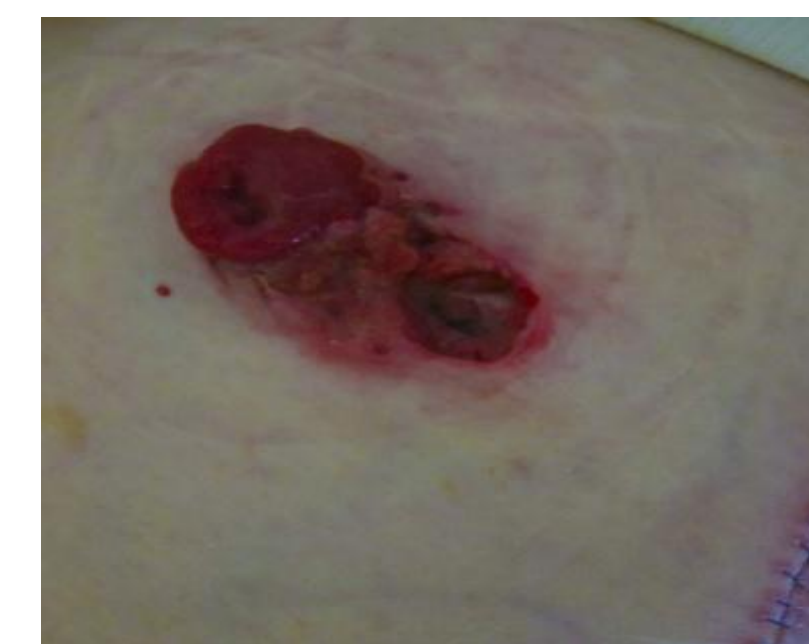
Fig 1 :

Start of the new regime: Wound size: 3 x 3 x 3 cm.

The 82-years old female patient with a stagnating abdominal wound after reconstruction of an ileostomy. She has diabetes melitus type1 (insuline: 8 a.m, 23 units; 6 pm, 36 units). Leakage of stool into the wound occurs frequently. Previous regime: Rinsing with saline, alginate covered with the plate of the 2 piece ostomy system. At 3 days there was no improvement. New regime: As described for case 1. After 8 days of collagen dressing use, granulation and epithelialization started. Fig 1, Fig. 2 and Fig.3.

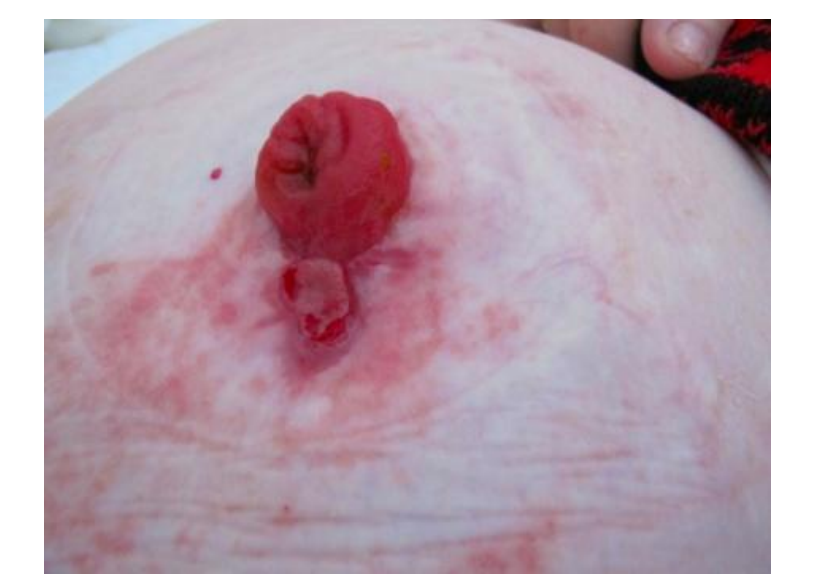
Fig 3:

Situation after 21 days, the wound is superficial and is now covered with an alginate, fixed with a film. At day 28 the wound was closed.

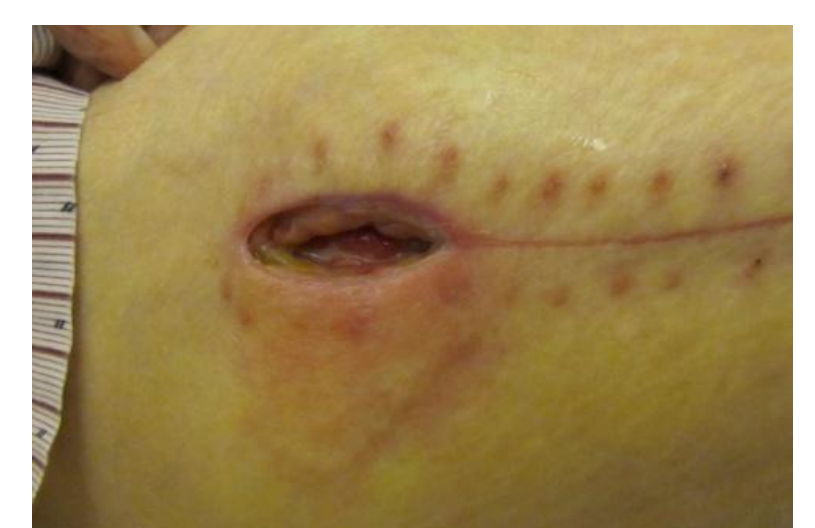
Fig 4:

At the start the ulcer size is 4 x 3 x 2 cm, 30% slough, 70% granulation, with inflamed wound edges.

86-Years old, otherwise healthy male patient, status after his total hip, the surgery wound became infected. The open wound produced copious serous exudate. Fig.4. Previous regime: Rinsing with saline, saline soaks, covered with a standard absorbent dressing. The infection had subsided, leaving a stagnating wound. New regime: As described for case 1. After 10 days of \*collagen treatment, granulation started again. Fig.5. Seven days later the wound had healed.

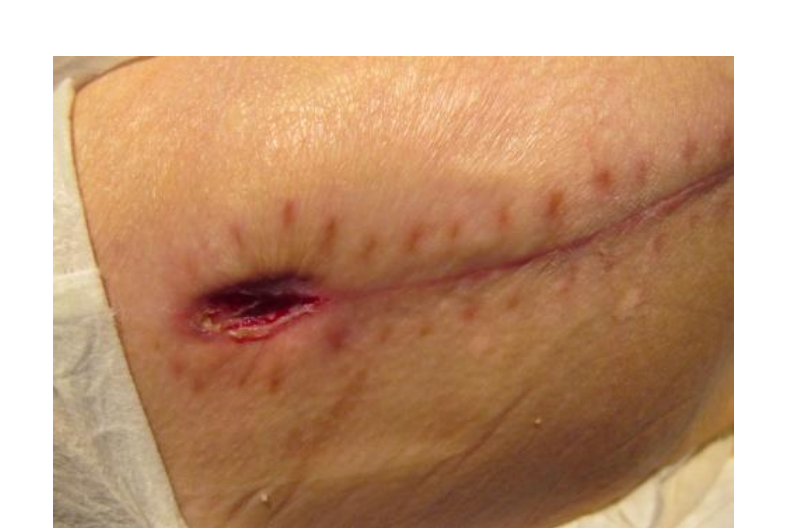
Fig 5:

At 14 days the wound size was 2x1.5x0.5 cm

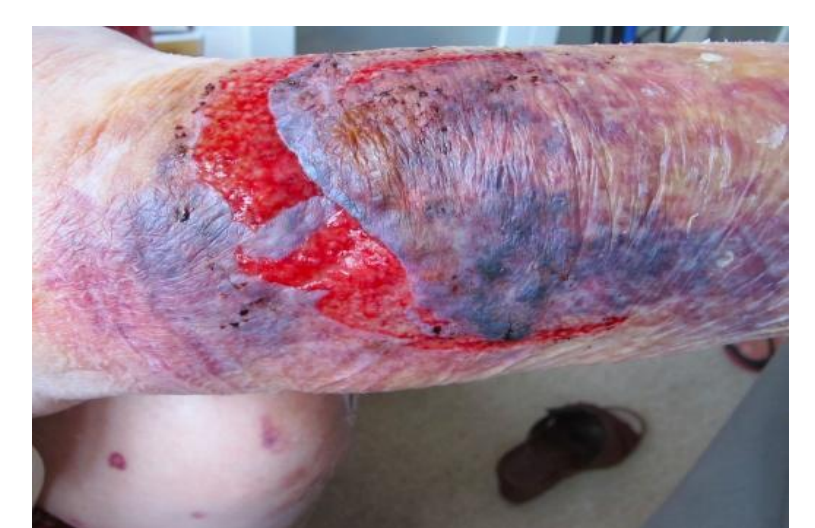
Fig 6:

Wound size 15x3x1 cm, 90% granulation.

92-Years old female patient with an extensive tibia skin tear, after falling. She had a stroke 8 years ago and lost part of her left arm function. Previous regime: povidon iodine gauze, covered with an absorbent dressing, fixed with a retention bandage. Fig.6. New regime: The vital part of the skin flap was adjusted over the wound. Fig.7. She received treatment with \*collagen, covered with \*\*foam and a \*\*\*\*\* tubular compression system. Fig.8. The dry skin was treated with a moisturizer. After 14 days the wound showed a significant improvement. At 21 days the wound size was 4.5x1.5 cm. Fig.8 and wound closure was achieved after a total of 7 weeks. Fig 9.

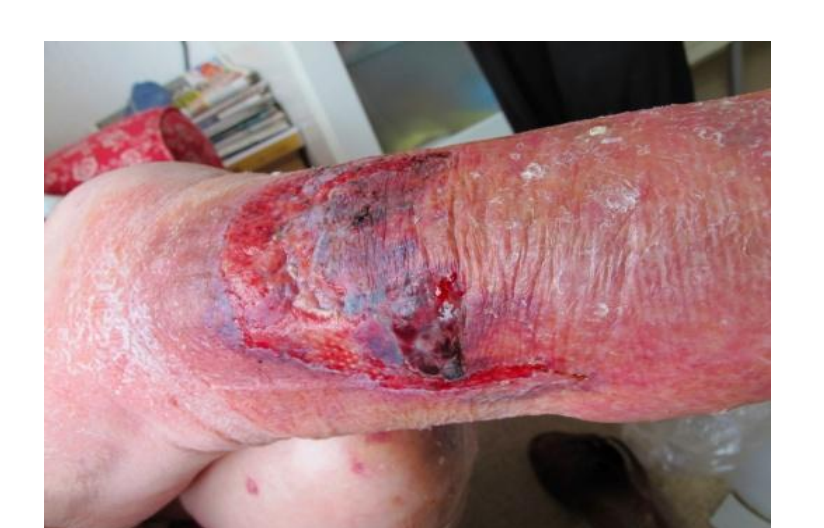
Fig 7:

The flap is placed over the wound

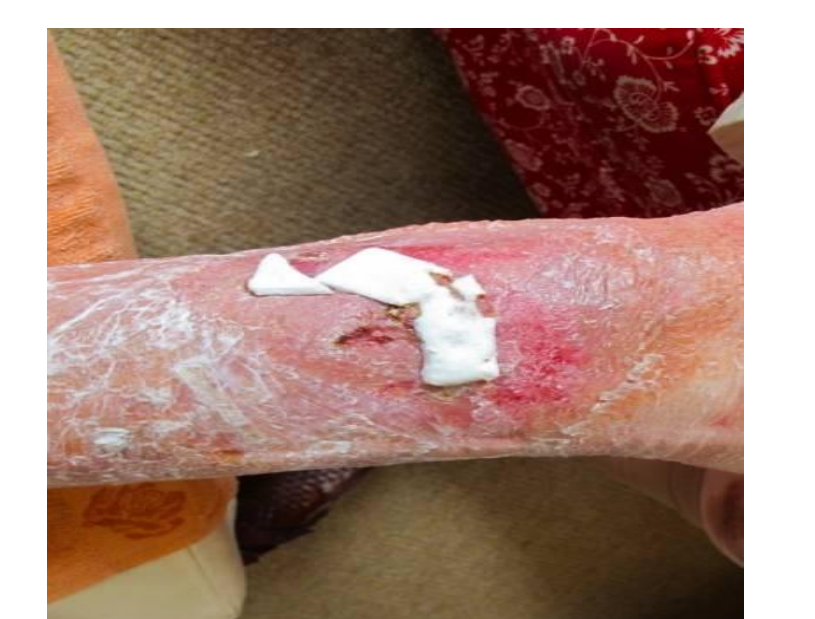
Fig 8: Situation at 21 days

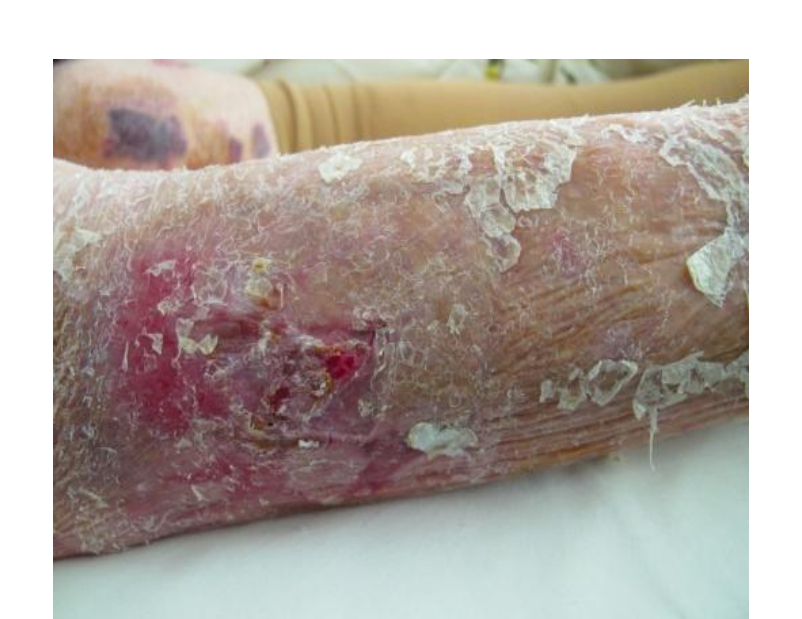
Fig 9: Wound is closed at 7 weeks

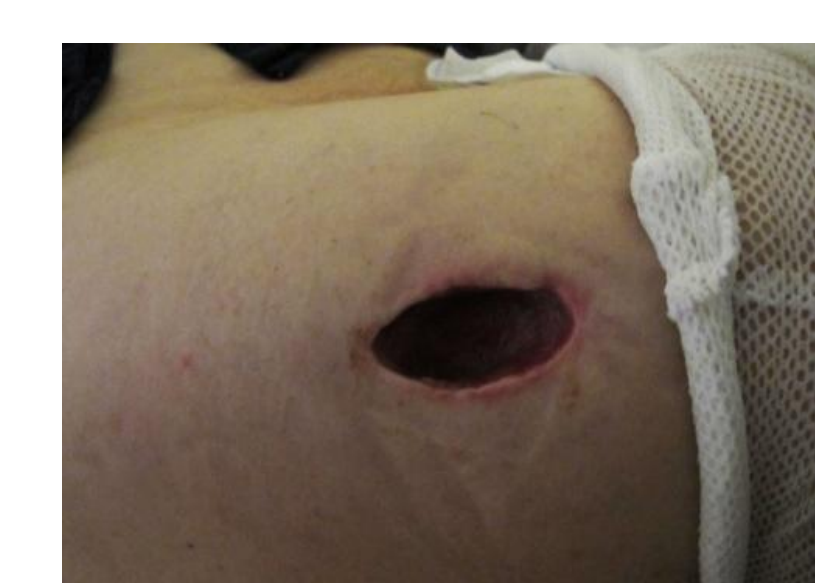
Fig 10:

Staples are removed

78-Years old male patient with a femur wound after a biopsy, when he was diagnosed with Still's disease. (Chronic joint inflammation). The staples are removed and pus was released. Fig.10. Previous regime: rinsing with water and saline soaks, systemic antibiotics. After 7 days this was changed to: \*collagen, covered with an \*\*\*\*alginate and fixed with a film. Fig 10 – 13. After 8 weeks the wound had healed.

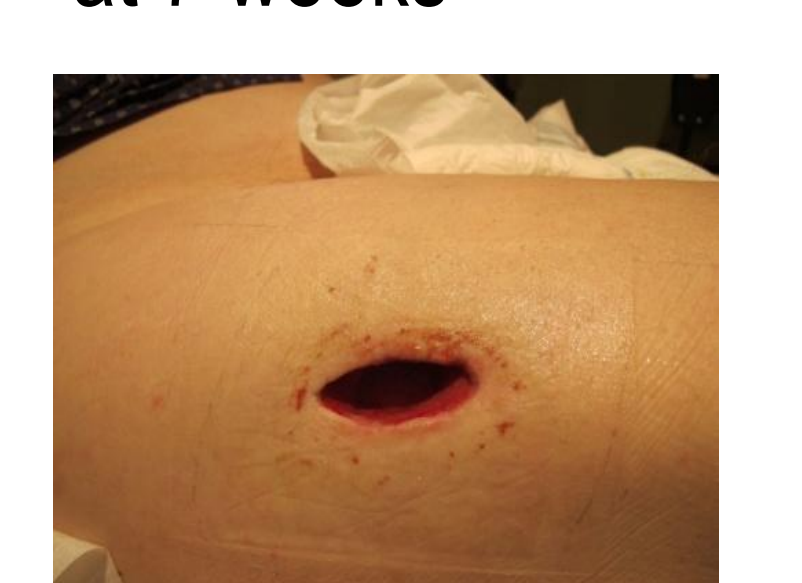
Fig 11:

Situation at 3 weeks

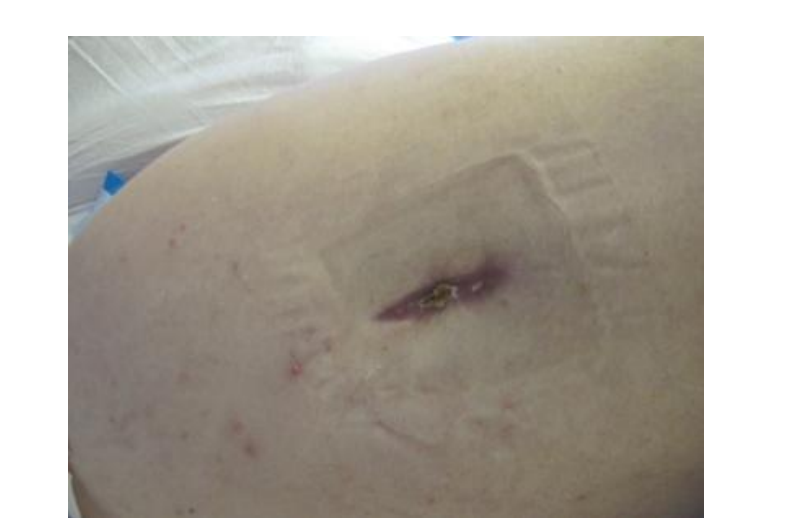
Fig 13:

Closed at 8 weeks
